## Islesboro Economic Sustainability Corporation

### **Islesboro Economic Sustainability Corporation – Board Meeting**

# Figure 3 – Project Organization Flow Chart

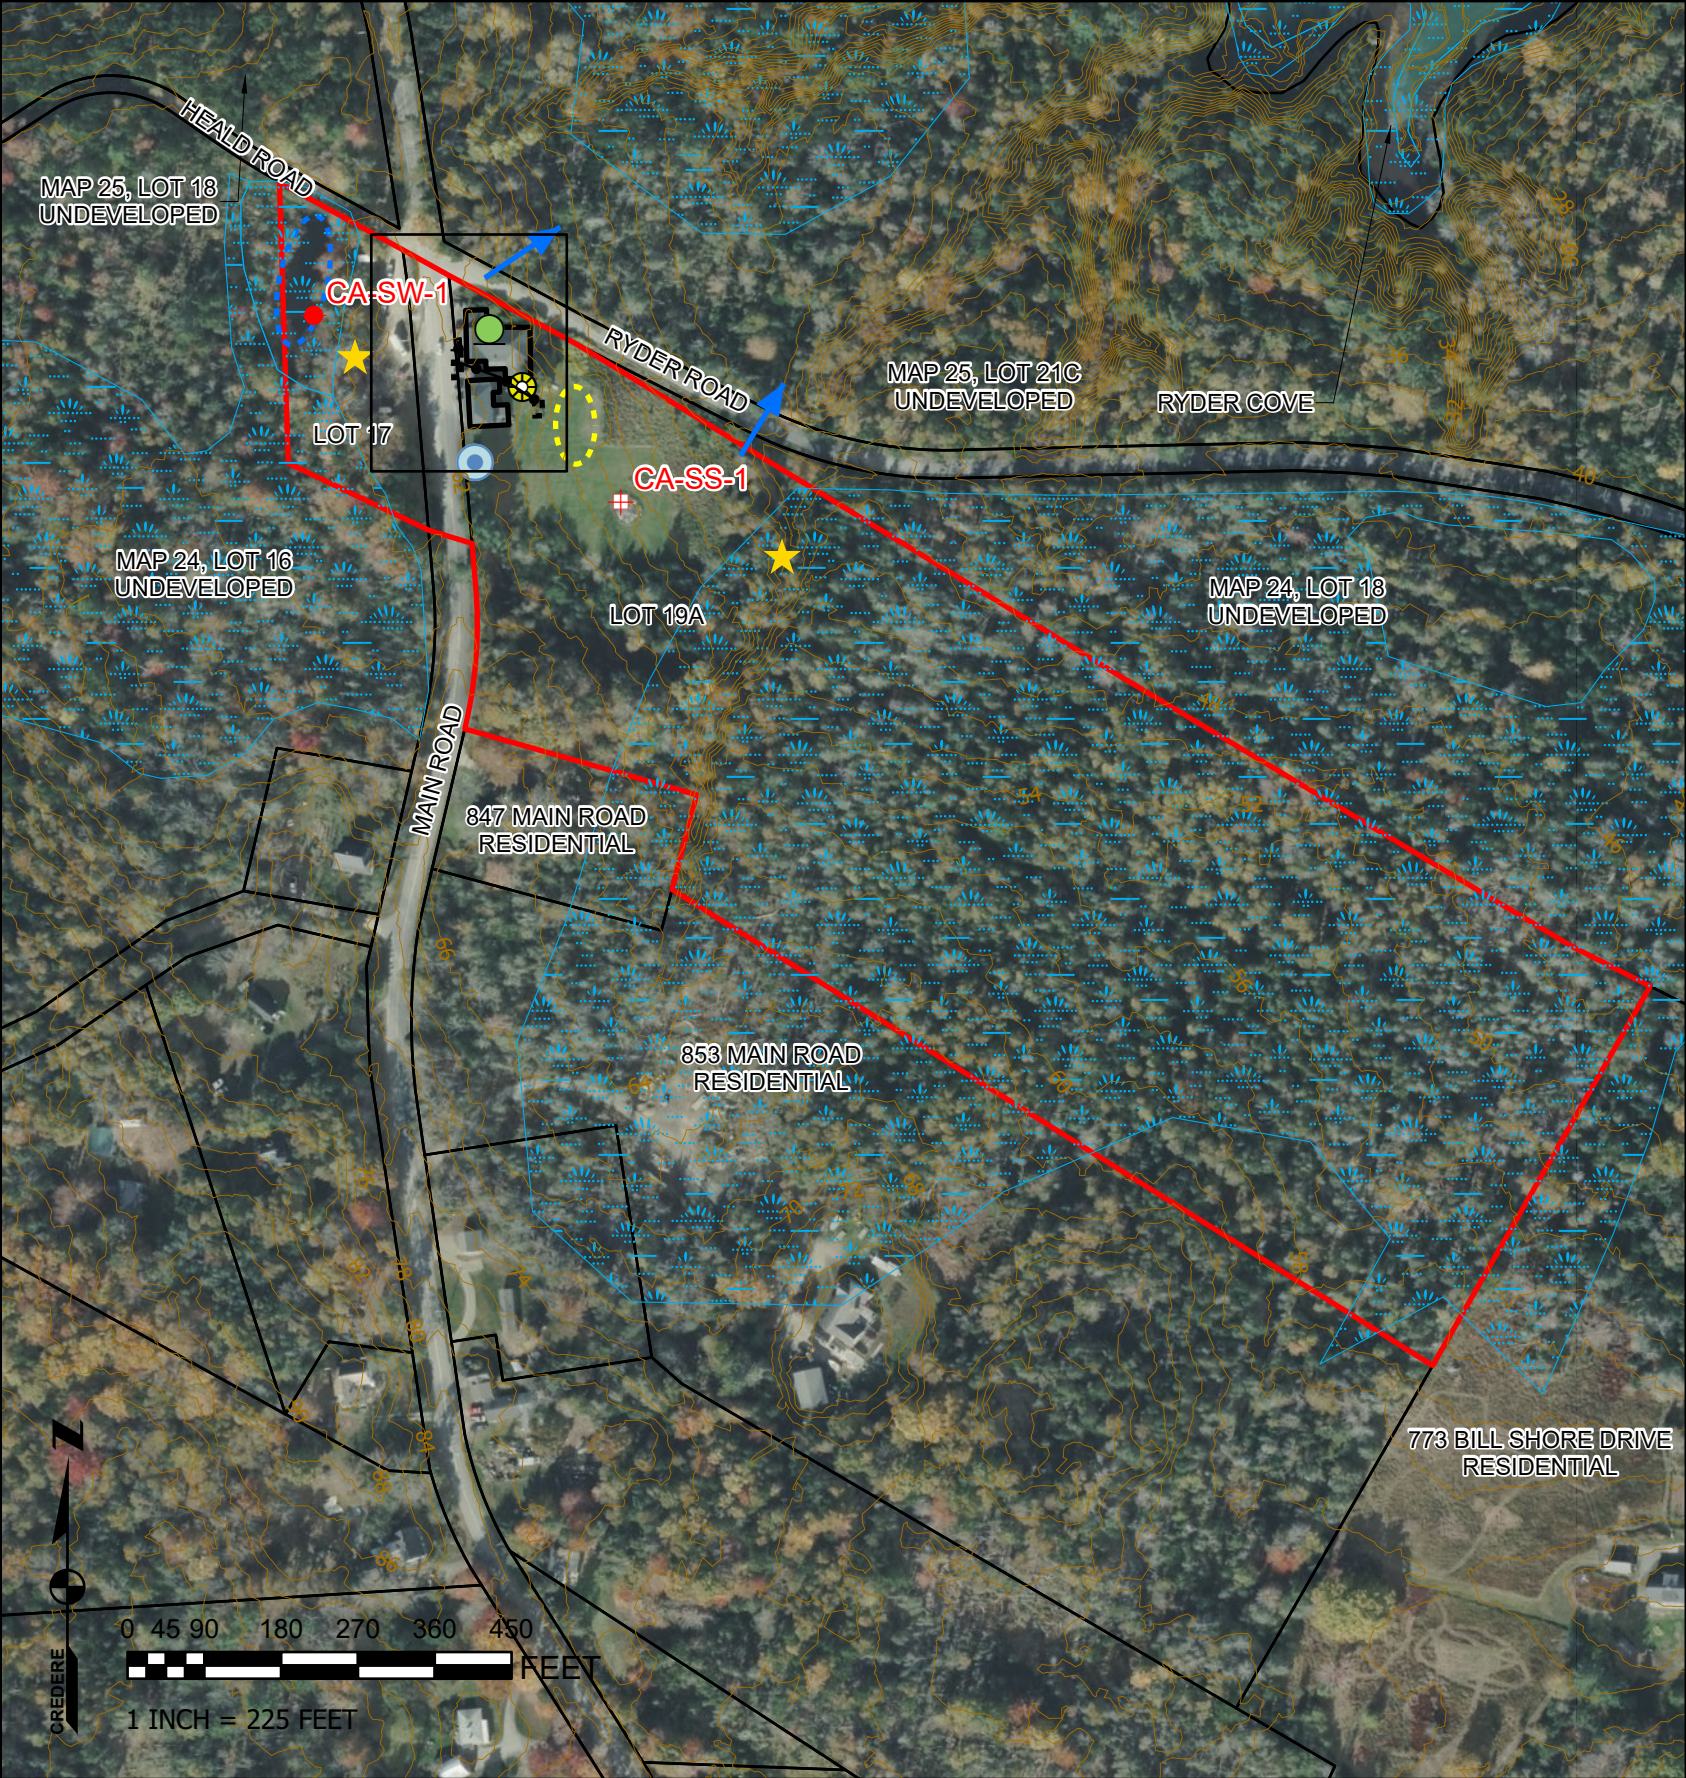
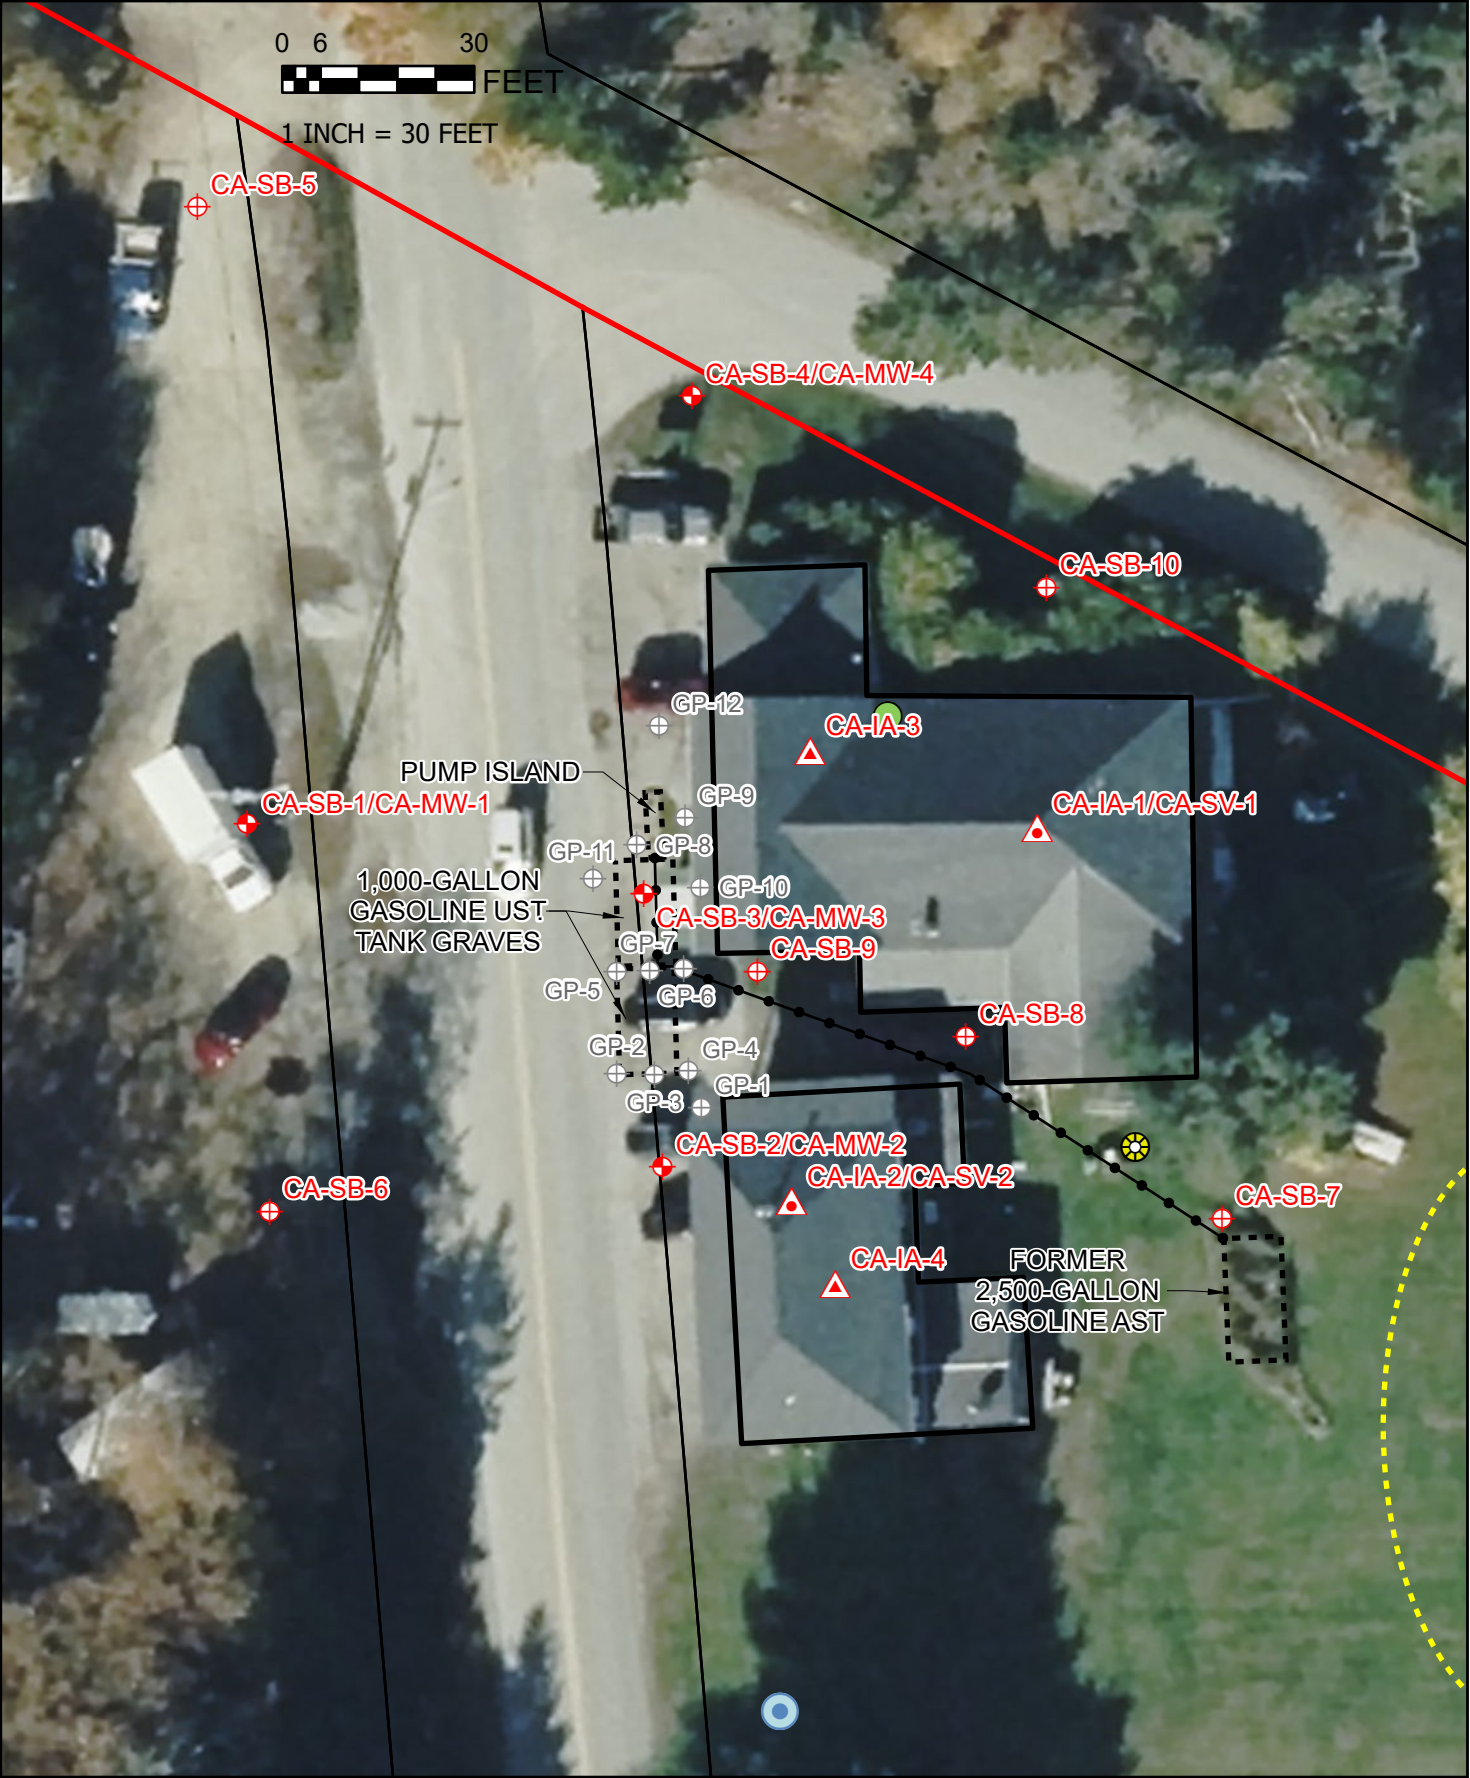
In addition, one composite surface soil sample (CA-SS-1) is planned to be collected from the observed burn pile area to assess for impacts to soil from this use.

Two sub-slab soil vapor samples (CA-SV-1 and CA-SV-2) will be collected, one from each Site building, where a foundation slab is present to assess for the potential for vapor intrusion into the buildings. The soil vapor samples will be collected using a stainless-steel soil vapor probe into soil beneath the foundation slab. As several cracks/penetrations to the subsurface were observed in the general store basement, and the entirety of the residence/former firehouse slab could not be viewed to examine whether penetrations or cracks exist, installation of a permanent soil vapor point in the general store basement would not effectively represent subsurface conditions below the slab as a complete seal from indoor air could not be obtained. Installation of a permanent soil vapor point will occur in the firehouse building only if no major penetrations or cracks preventing a complete seal are observed. CA-SV-1 will be installed in the eastern portion of the general store basement. CA-SV-2 will be installed in the northern portion of the former firehouse first floor. If groundwater is encountered beneath the slab in the general store basement, a groundwater grab sample will be collected.

Four indoor air samples (CA-IA-1 to CA-IA-4), one on each floor of each Site building, will be collected to assess for a complete pathway from soil vapor to indoor air. CA-IA-1 and CA-IA-2 will be co-located with CA-SV-1 and CA-SV-2, respectively. CA-IA-3 will be located in the first floor of the general store and CA-IA-4 will be located in the second-floor residence of the former firehouse building. Prior to completing this indoor sampling work, observed chemicals in the buildings will be inventoried so the indoor air sample results can be cross-checked for background sources.
